A Special Report from Alberta Oil Tool

Root Cause Failure Analysis is Essential for Failure Frequency Reduction in Wells With Artificial Lift.

Excerpted from Sucker Rod Failure Analysis by: Clayton T. Hendricks and Russell D. Stevens

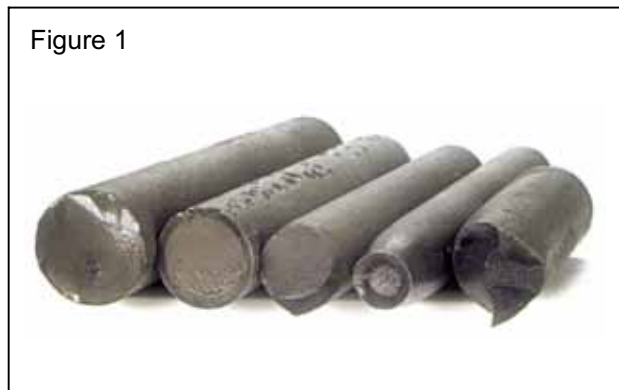
Figure 1 is an example of tensile and fatigue failures. The two examples on the right are tensile failures. A tensile failure is characterized by a reduction in the diameter of the cross-sectional area at the point of fracture. Typical tensile failures have cup-cone fracture halves. The second example from the right is typical in appearance for tensile failures. During the final stages of an overload, fractures from tensile failures rupture, or shear, on 45° angles to the stresses applied. A good example of the shear is the characteristic cup-cone fracture surfaces of a typical tensile failure. The rod body on the right is an excellent example of needing to look past the obvious for the not so obvious. A fatigue failure

is primarily responsible for the failure even though fracture occurred while trying to unseat a stuck pump. Visual examination of the fracture surface reveals a small semi-elliptical, stress fatigue crack. This sucker rod had pre-existing, transverse fatigue cracks, from in-service stresses. One of the stress fatigue cracks opened during the straight, steady load applied in attempting to unseat the pump, and fracture occurred. The tensile failure is secondary and results in the unusual appearance of the fracture surface – with the small fatigue portion, large tensile portion and unusually large 45° double shear tears.

The remaining examples are fatigue failures on: casehardened sucker rods; normalized and tempered sucker rods; and quenched and tempered sucker rods. The example on the far left is a torsional fatigue failure from a progressing cavity pump. Ratchet marks found in the large fatigue portion, and originating from the surface of the rod body, completely encircle the fracture surface with the small tensile tear portion shown slightly off middle-center. The second rod body on the left is a casehardened fatigue failure. The case encircling the rod body diameter carries the load for this high tensile strength sucker rod and if you penetrate the case, you effectively destroy the load-carrying capability of this type of manufactured sucker rod. The fatigue crack advances around the case and progresses across the rod body. A fatigue failure on a casehardened sucker rod generally exhibits a small fatigue portion and a large tensile tear. The third rod body from the left is typical in appearance for most fatigue failures. Typical fatigue failures have a fatigue portion, tensile portion with a final shear tear. The width of the fatigue portion is an indication of the loading involved with the fracture. Mechanical damage can prevent or hinder failure analysis by destroying the visual clues and identifying characteristics normally found on a fatigue fracture surface. Care must be exercised when handling the fracture halves. It is very important to resist the temptation to fit the mating fracture surfaces together since this almost always destroys (smears) microscopic features. To avoid mechanical damage, fracture surfaces should never actually touch during fracture-surface matching.

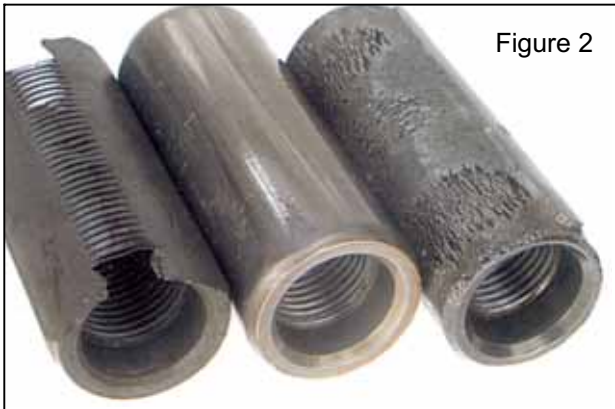
Figure 2

Figures 2 and 3 are examples of design and operationally induced mechanical failures. Wear, flexing fatigue, unidirectional bending fatigue, and stress-fatigue failures indicate compressive rod loads, deviated wells, fluid pound, gas interference, highly stressed sucker rods, improperly anchored tubing, pumps tagging bottom, sticking pump plungers, unanchored tubing, or some combination of the preceding.

Wear causes rod failures by reducing the cross-section of the metal, exposing new surface metal to corrosion, and causes joint failures from impact and shoulder damage. The Class T coupling on the left, the

Class SM coupling second from left, and the rod body on the left are all examples of wear. Wear on the sucker rod string is defined as the progressive removal of surface metal by contact with the tubing. Wear that is equal in length, width, and depth usually suggests a deviated or crooked well bore. Angled wear patterns indicate rod strings that are aggressively contacting the tubing at an angle, usually as a result of fluid pound or unanchored (improperly anchored) tubing. The middle rod body represents corrosion-abrasion wear. Wear also removes corrosion inhibiting films and exposes new surface metals to corrosive well fluids-which accelerate the rate of corrosion. The Class T coupling on the far right has a work-hardened ridge from tubing-slap wear. Tubing-slap wear is the result of the rod string "stacking out" – probably as a result of fluid pound, gas interference or pump tagging. The work-hardened material doesn't wear as fast as the softer material on either side of the work-hardened area, and it leaves a ridge of material as the rest of the coupling wears.

The second rod body from the left is a flexing fatigue failure. Flexing fatigue failures occur from the motion of the rod string having a constant lateral or side movement during the pumping cycle. Stress fatigue cracks due to flexing will concentrate along the area of the rod where the greatest bending stresses occurred. The transverse, stress fatigue cracks will be on one half of the circumference of the rod body, closely spaced near the rod upsets and gradually spreading apart moving toward the middle of the rod body. Most flexing fatigue failures occur above the connection in the transition zone of the rod body-between the rigid coupling and upset area and the more flexible rod body. Flexing fatigue failures will not show permanent bends since this problem occurs while the rod string is in motion. The example on the far right is a unidirectional bending fatigue

failure. This type of failure generally has two lips protruding above the fracture surface. These distinct failure characteristics indicate a double shear-lip tear. Double shear-lip tears are the direct result of unidirectional bending stresses, with fractures and the fatigue damage occurring under compressive rod loads. Compressive rod loads may be the result of large bore pumps with small diameter sucker rods or multiple tapers in shallow wells.

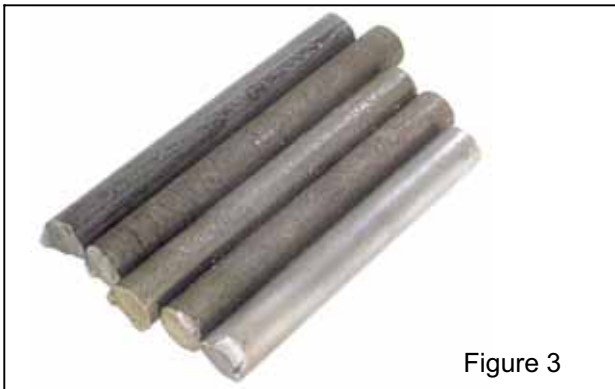
Figure 3

The second rod body sample on the right (Figure 3) is a stress fatigue failure. Stress fatigue failures occur on highly stressed sucker rods as a result of worn out sucker rods, overloads, or extremely high rod loads for short periods of time. Stress fatigue failures may have closely spaced, fine, transverse secondary fatigue cracks that completely encircle the circumference of the rod body. The stress fatigue cracks may be on the wrench square and over the entire length of the rod body. With very old sucker rods, stress fatigue cracks and failure may occur within normal everyday operating loads.

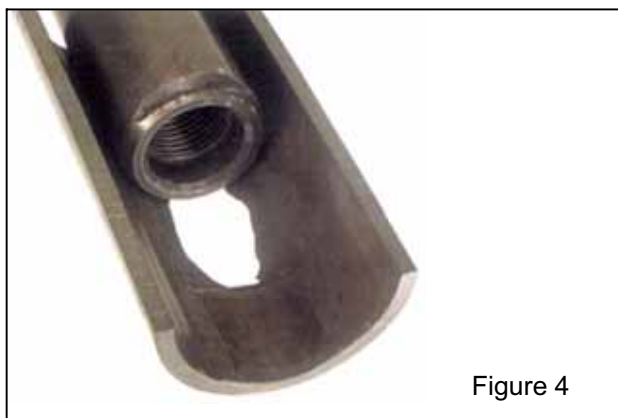
Figure 4 is an example of coupling-to-tubing slap. Coupling-to-tubing slap is the result of extremely aggressive angle contact to the tubing by the rod string. This aggressive contact is the direct result of severe fluid pound, unanchored (or improperly anchored) tubing, sticking (or stuck) pump plungers, or any combination of the preceding.

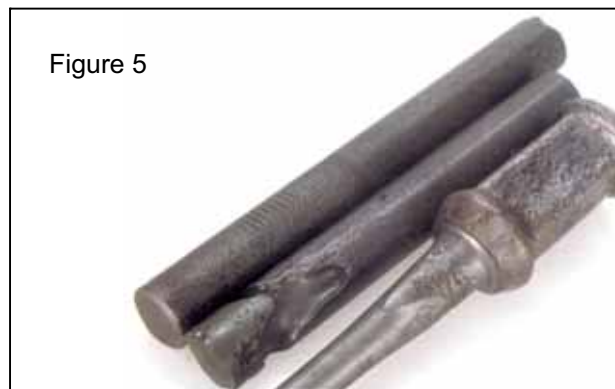
Figure 5 is an example of rod guide related damage. The example on the left is a reconditioned, high tensile strength sucker rod. Turbulent fluid flow, associated with short, blunt-end injection molded rod guides, allowed crevice corrosion in the critical wash area around the end of the guide. Prior to inspecting the mold-on rod guides were removed from the rod body for reconditioning. Class 1 reconditioned sucker rods cannot have discontinuities greater than 20 mils (0.020") per API Specification 11BR. The crevice corrosion was under the 20 mils allowed for a Class 1 reconditioned sucker rod. However, the notch sensitivity (discontinuity intolerance) of a high tensile strength sucker rod is high. In other words, small pits can be detrimental to the high tensile stresses associated with the high strength sucker rod and reconditioned high strength sucker rods should be de-rated for load. The example in the middle is an erosion/corrosion failure resulting from short, blunt-end; field applied rod guides in small tubing with high fluid velocities. Erosion/corrosion pits will be "fluid cut" with very smooth bottoms. Pit shape characteristics may include sharp edges and steep sides if accompanied by CO₂ or broad smooth pits with beveled edges if accompanied by H₂S. The example on the right is abrasion wear from a field-applied guide moving up and down on the rod body during the pumping cycle. Generally speaking, mold-on rod guides provide better laminar flow, a minimum of three to four times more bonding and holding power and are more cost-effective than are field applied rod guides.

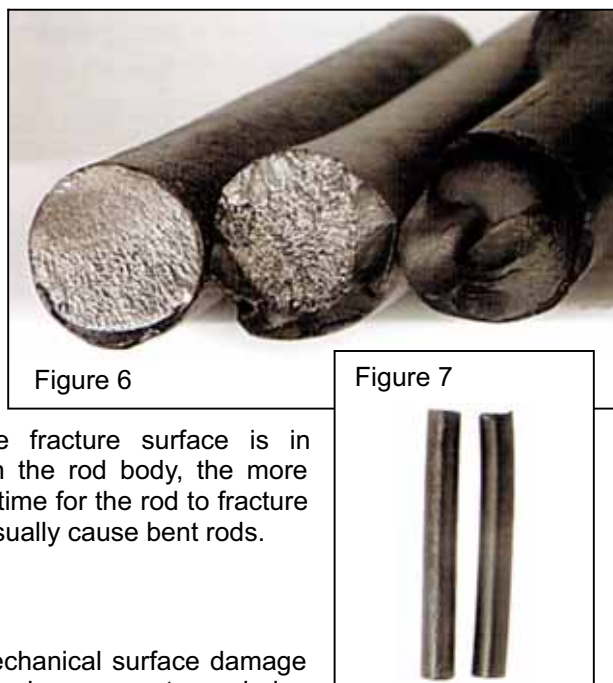
Figure 6 (with inset of Figure 7) is an example of bending fatigue failures. Bending fatigue failures can be identified by the angled fracture surface, which will be at some angle other than 90° to the axis of the rod body. The example on the left illustrates a fracture caused by a long radius bend, or gradual bow in the rod body (left example in Figure 7). The fracture surface shows fatigue damage, and has a slight angle when compared to the axis of the rod body. The middle example is a short radius bend (right example in Figure 7). The fracture surface is at a greater angle to the axis of the rod body with a small fatigue portion and a large tensile tear portion. The example on the right is the result of a corkscrewed sucker rod. Notice how convoluted the fracture surface is in appearance. As a general rule, the greater the bend in the rod body, the more convoluted the fracture surfaces appear. In operation, the time for the rod to fracture is greatly shortened. Poor care and handling procedures usually cause bent rods.

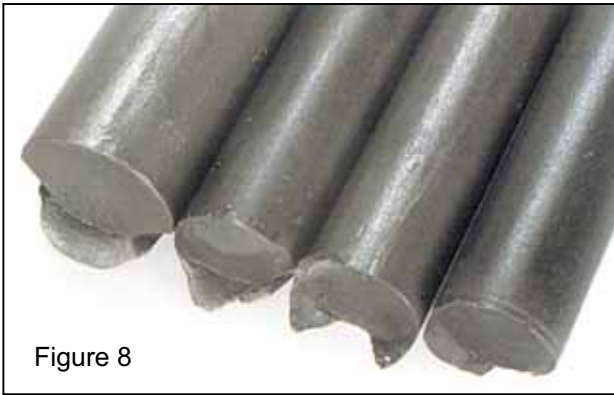
Figure 8 is an example of various surface damage failures. The example on the left shows a slight depression from a wrench, tool, or other metal object. The second example from the left is damage from a pipe wrench used in applying field-installed rod guides. The second example from the right has a small longitudinal scratch, through metal-to-metal contact, by allowing sucker rods to run down other rods in a rod bundle during installation. The example on the right exhibits transverse surface damage.

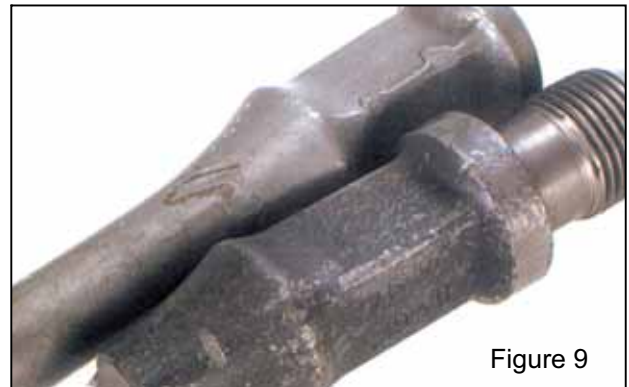
Figure 9 is an example of surface damage caused by sucker rod elevators. The bottom example is damage from worn or misaligned elevator seats. After an extended period of service, the elevator seats become so worn that they develop an oval shape rather than a round shape. As the oval shape grows, the tangency ring of the rod upset to the elevator seat face is lowered in the front half of the seat. As the seat continues to wear the seating position of the rod upset is moved forward of the elevator trunnion centerline. This causes an offset in the hook load and tilts the elevator body forward. When the elevator lifts the rod string load, the hook load will bend the sucker rod centerline to coincide with the elevator trunnion centerline. As the rod string weight increases, the hook load will bend every sucker rod engaged by this elevator. Bent sucker rod failures that occur below the surface upset bead may be from bad elevator seats. The top example is damage caused by the elevator latches. This type of damage normally occurs as a result of picking up or laying down in doubles. Never pick up or lay down anything more than one single sucker rod. Anything else causes the elevator latches to act as a fulcrum and allow bending stresses to concentrate in the transition zone of the rod body and the forged upset.

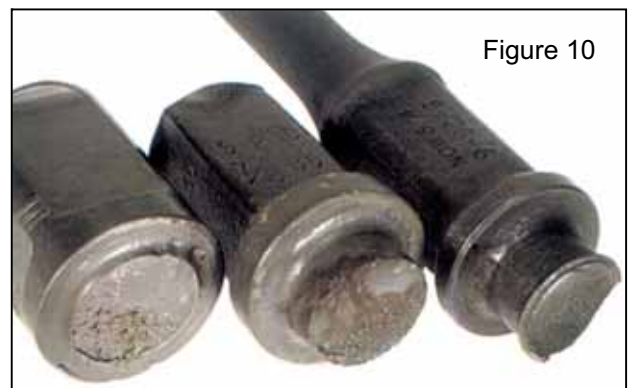
Figure 10 is an example of pin failures due to a loss of displacement. The sample on the right is typical in appearance for a loss of displacement pin failure. Insufficient makeup, or the loss of tightness, caused the pin shoulder face and the coupling shoulder face to separate. When these faces separate, a bending moment is added to the tensile load in the pin. The threaded section of the pin is held rigid while the rest of the pin flexes. The motion of the rod string causes stress fatigue cracking to start in the first fully formed thread root above the undercut. Small fatigue cracks begin along the thread root and consolidate into a major stress fatigue crack. The fracture surface of a typical loss of displacement pin failure has a small fatigue

portion covering approximately one-third of the fracture surface with the tensile tear portion and final shear tear covering the remaining fracture surface. The examples on the left and in the middle will occur as a result of stress loading when stress-raising factors such as corrosion or mechanical damage is present on the surface of the pin undercut.

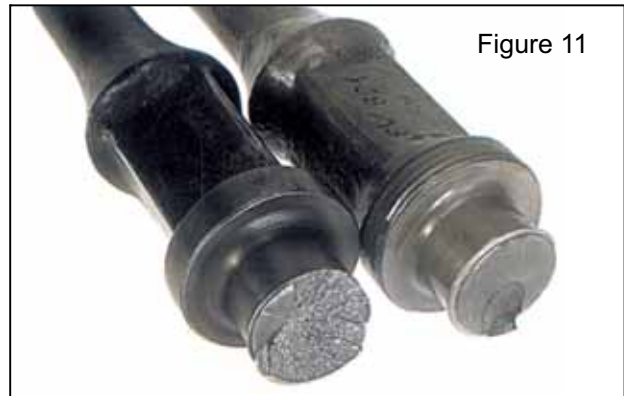
Figure 11 is another example of two types of pin failures. The sample on the left is typical in appearance for a loss of displacement pin failure. However, this pin fracture was caused by the hydraulic rod tongs during makeup as is evidenced by the stair-stepped tensile tear. It is not uncommon for pin fractures to occur at makeup, if the pin has a pre-existing stress fatigue crack due to the high torque required during joint makeup, with large diameter Class D and all sizes of high tensile strength sucker rods. The sample on the right is an example of excessive torque on a soft pin. The fracture surface has a large fatigue portion, with multiple ratchet marks in the pin-thread root, and a small tensile portion.

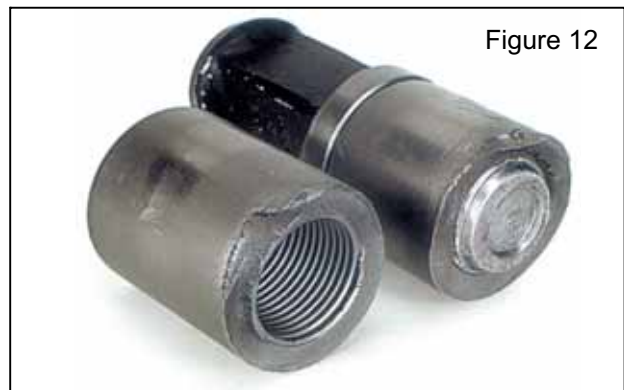
Figure 12 is an example of a loss of displacement coupling failure. The fracture initiated in the coupling thread-root opposite the first fully formed pin starting thread. One-third/two-third fracture halves, in length, with ratchet marks originating in the thread root indicate a loss of displacement coupling failure. The fracture surface of a typical loss of displacement coupling failure has a small fatigue portion and a large tensile tear portion. Loss of displacement coupling failures are primarily associated with Class D sucker rods and high tensile strength sucker rods.

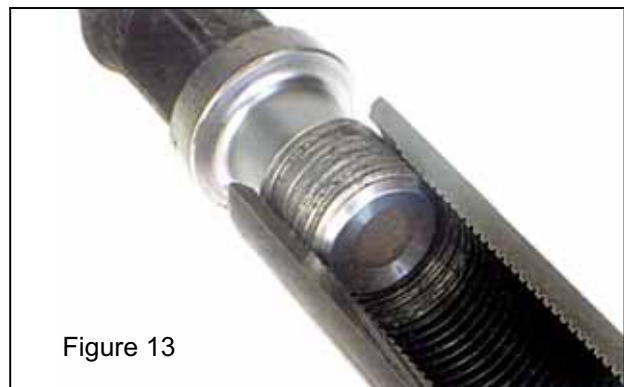
Figure 13 is an example of thread galling in the sucker rod connection. Thread galling is mechanical damage to the sucker rod and/or coupling threads. Thread galling is the result of damaged or contaminated threads causing the interference between the threads to be great enough to rip and tear the thread surfaces. The threads weld together during makeup and strip apart at breakout and the connection is damaged and destroyed beyond use. Hard stabbing damage to the leading thread, contaminated threads and cross threading on larger diameter rods are the primary causes of thread galling. Cleaning the threads prior to makeup, properly lubricating the threads and following careful makeup procedures will prevent thread galling.

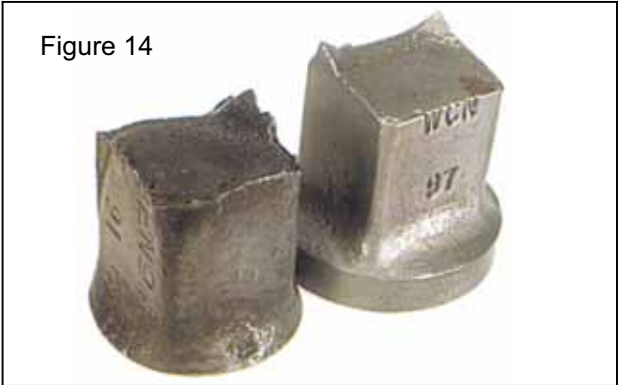
Figure 14 is an example of wrench square failures. Wrench square failures are extremely rare and seldom occur unless from mechanical damage, corrosion, manufacturing defects or torsional stress causing fatigue damage. The example on the left is a wrench square failure from severe mechanical damage. A loose

or sloppy backup on the hydraulic rod tongs has rounded the wrench square corner. The stress fatigue crack began in the corner of the wrench square and progressed to final rupture or fracture.

The example on the right is a wrench square failure from a manufacturing defect. The failure initiated in the die stamp mark and is an example of an excessive die stamp depth failure. Die stamp markings can become notches that serve as stress raisers if the depth of the die stamping, during the forging process, is not controlled and kept within API Specification 11B, allowable tolerances.

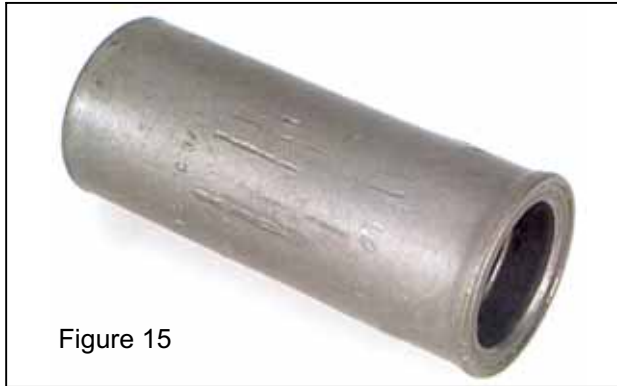
Figure 15 is an example of the damage that occurs as a result of severely over-tightening the sucker rod connection. The example shown is an over-tightened coupling that has flared out or bulged near the contact face. Slim-hole couplings are more susceptible to this type of over-tightened damage than are full sized couplings. Over-tightened full size couplings on Class D and high strength sucker rods generally exhibit slight bulges and have the concentric deformation ridge of material on the coupling shoulder face from the impression of the pin shoulder face. Over-tightening with hydraulic rod tongs will twist off soft pins resulting in a tensile failure appearance. The pin undercut will neck

down and fracture occurs rapidly. With Class D sucker rods, an indication of over-tightening is the concentric deformation ridge of material on the pin shoulder face from the impression of the coupling shoulder face. Over-tightening on normalized and tempered high tensile strength sucker rods will begin to pull the threads out of the coupling.

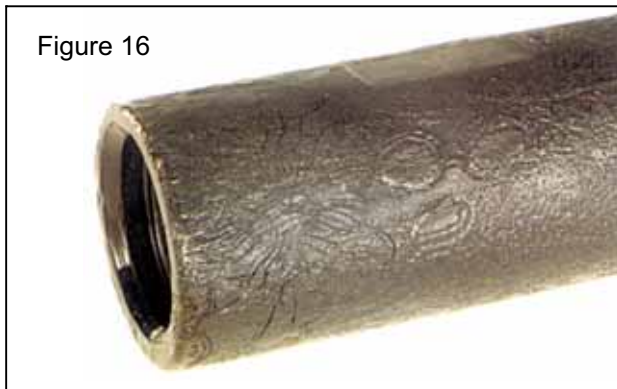
Figure 16 is an example of impact cracks on couplings. The practice of "warming up," or hammering, on couplings in order to loosen them should not be allowed. This example shows how impact damage to a Class T coupling causes stress fatigue cracks around the impact points and accelerated localized corrosion. Hammering on Class SM couplings causes stress fatigue cracks in the hard spray surface and results in a coupling failure due to stress/corrosion fatigue.

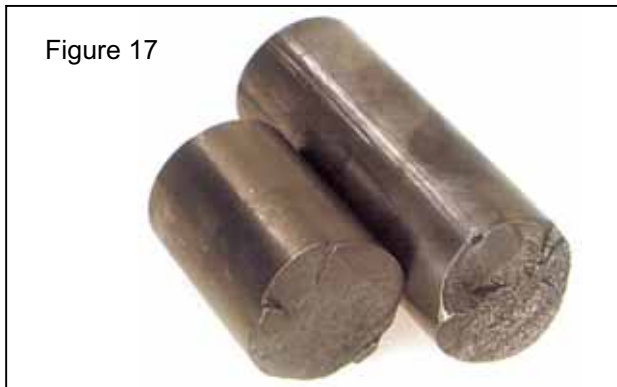
Figure 17 is an example of polished rod failures. The majority of all polished rod failures occur either in the body, just below the polished rod clamp, or in the pin. Polished rod body failures below the polished rod clamp result from the addition of bending stresses. These bending stresses may be imposed by pumping units out of alignment, carrier bars that do not set level, worn carrier bars, misaligned load cells, or incorrect polished rod clamp installation. The polished rod failure on the left is an example of polished rod clamp on the sprayed portion of a Spraymetal polished rod. Spraymetal polished rods have an unsprayed portion for polished rod clamp placement. Never put a polished rod clamp on the sprayed portion of a Spraymetal polished rod. The polished rod failure on the right has small, longitudinal scratches caused from mishandling.

Polished rod pin failures generally occur due to the installation of sucker rod couplings. Polished rod pins have a 9Y thread taper between the straight-threaded section and the shoulder. Sucker rod couplings have a 30Y starting thread and a deep recess that doesn't engage all the polished rod pin threads. Polished rod couplings have a 9Y starting thread and a profile designed to properly fit the polished rod pin. The shallow recess to the first thread easily distinguishes polished rod couplings from sucker rod couplings and allows every polished rod pin thread to be engaged.

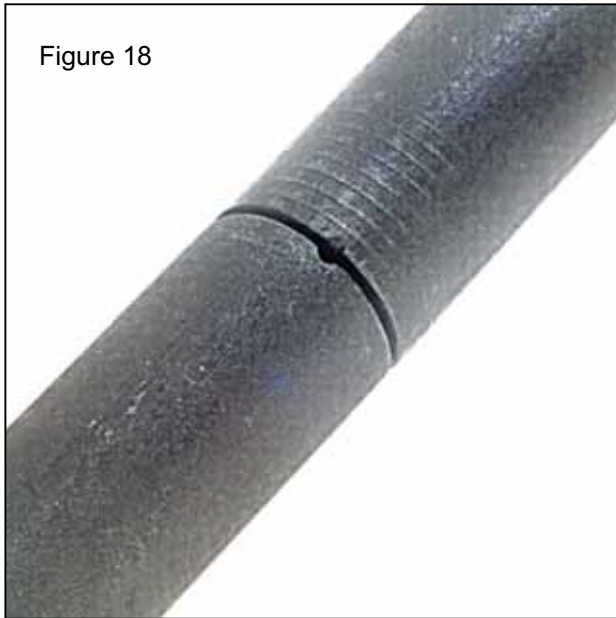
Figure 18 is an example of corrosion fatigue from CO₂ corrosion. The size of the pit, as far as when it becomes detrimental to the rod, depends on two factors—material type and hardness. Class K sucker rods may develop deeper and larger pits than a Class D sucker rod before it becomes detrimental to the rods. Class D sucker rods may develop deeper and large pits than a high tensile strength rod before it becomes detrimental to the rods. Softer materials with lower rod stress tolerate larger pits than do harder materials with higher rod stress. Therefore, small pits can be detrimental to higher tensile strength sucker rods as opposed to a softer rod that does not have as much rod stress.

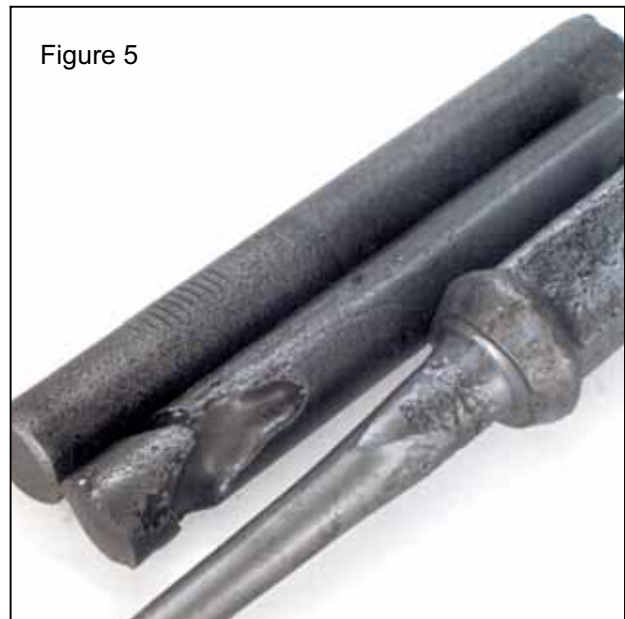
Service companies use acids for well stimulation and cleanout work. All acid work should have an inhibitor mixed with the acid prior to injection into the well. Spent acids are still corrosive to steel and the well should be “flushed” long enough to recover all acid. In rare instances, some produced waters contain organic acids that have formed downhole, such as acetic, hydrochloric and sulfuric acids. Corrosion from acid is a general thinning of metal, leaving the surface with the appearance of sharp, feathery or web-like residual metal nodules. Metallic scale will not be formed in the pits. The left sample in Figure 5 is an example of acid corrosion.

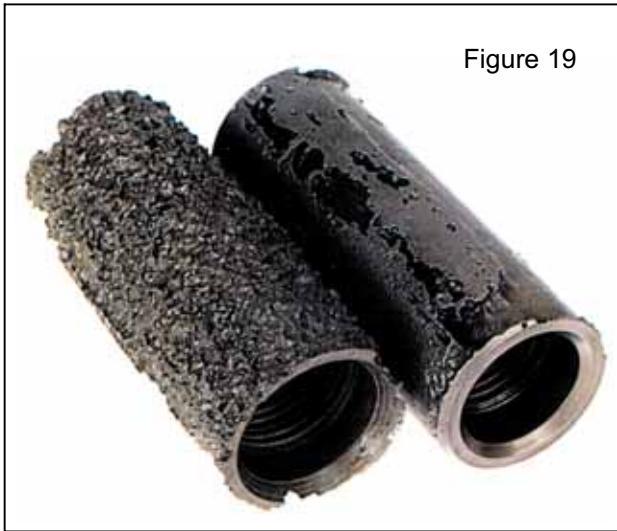
Figures 19 and 20 show typical examples of CO₂ corrosion. Figure 19 is an example of CO₂ corrosion on couplings and Figure 20 is an example of CO₂ corrosion on rod bodies.

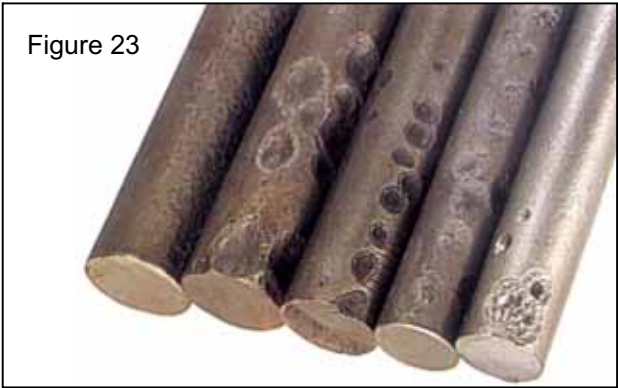
used on all suspect fluids to control bacteria populations. Bacteria are classified according to their oxygen requirements: aerobic (requires oxygen), anaerobic (no oxygen), and facultative (either). Some bacteria generate H_2S , produce organic acids or enzymes, oxidize soluble iron in produced waters, or any combination of the preceding. MIC has the same basic pit shape characteristics of H_2S , often with multiple stress cracks in the pit base, tunneling around the pit edge and/or unusual anomalies (i.e. shiny splotches) on the rod surface. Bacteria are very aggressive and all sucker rod grades corrode rapidly in downhole environments containing bacteria. Sulfate reducers (SRB's), those that produce H_2S , probably cause more problems to downhole artificial lift equipment than do any other bacteria type. Multiple cracking in the pit bases results from the hydrogen sulfide by-product of the bacterial lifestyle, which corrode and embrittle the surface of the steel under the colony. Figure 23 show several examples of microbiologically influenced corrosion (bacteria) on sucker rod bodies.

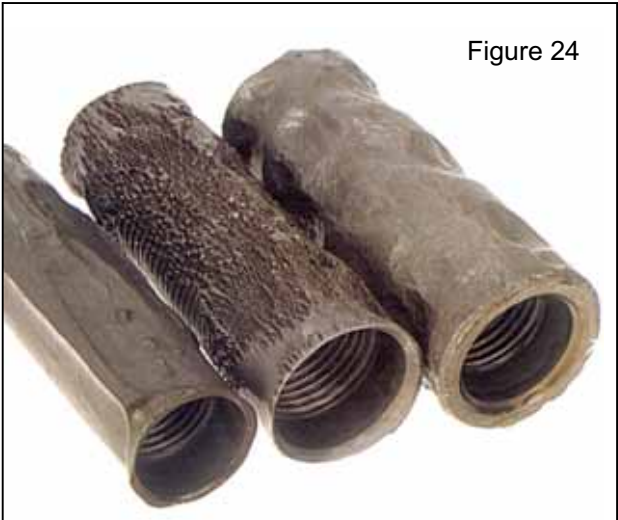
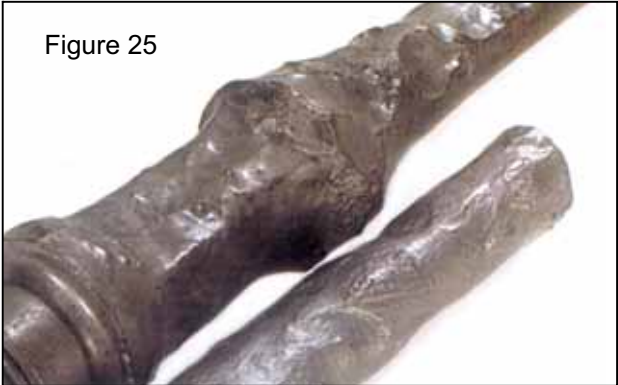
Figures 24 and 25 are examples of oxygen enhanced corrosion. The coupling sample on the left is an example of the effects of oxygen enhanced CO_2 corrosion (left), H_2S corrosion (middle), and chloride corrosion (right) while the rod samples in Figure 25 show the effects of oxygen enhanced CO_2 corrosion near the upset (left) and CO_2 corrosion on the rod body (right).

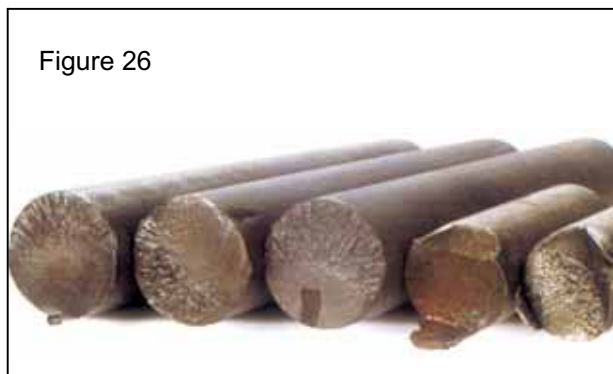
Figure 26 is an example of mill defects. Mill defects occur along one side of the rod body and these discontinuities normally have longitudinally tapered, sharp "V" shaped bottoms with indications of the longitudinal seam in the base. The example on the far left is an example of a sliver. The rod body third from the left is also an example of a sliver. When fishing the rod failure, the sliver folded against the fracture surface. The rod body second from right is an example of a scab. A sliver is a small loose or torn segment and a scab is a large loose or torn segment of material longitudinally rolled into the surface of the bar. One end of the sliver or scab is normally metallurgically bonded into the rod body while the remaining end is rolled into the surface and physically attached. Fatigue failures, which result from slivers or scabs, will have a piece of loose material protruding over the fatigue portion of the fracture surface. The rod body second from the left is an example of rolled-in-scale. Rolled-in-scale is a surface discontinuity caused when scale (metal-oxide), formed during a prior heat, has not been removed prior to bar rolling. The rod body sample on the far right is an example of a rolling lap. Rolling laps are longitudinal surface discontinuities that have the appearance of a seam from rolling, with sharp corners folded over and rolled into the bar surface without metallurgical bonding.

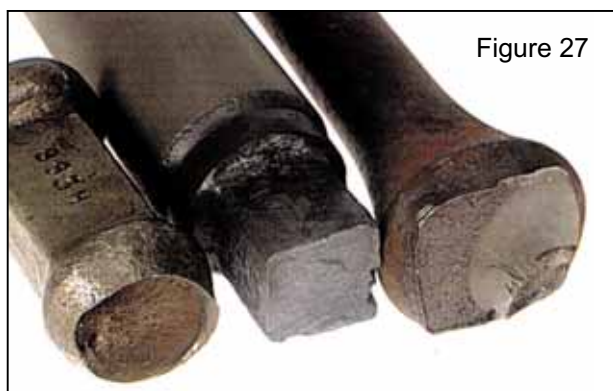
Figure 27 is an example of forging defects. The fracture begins internally below a forging crack in the upset area and is brittle or granular in appearance. A crack initiation site may or may not be visible and a fatigue portion may not be present on the fatigue fracture surface. The examples on the left and in the middle occur as a result of low forging temperatures. The example on the left is a failure from cold-shut and the example in the middle is a failure from a forging crack. The fracture on the right is a failure caused by a subsurface longitudinal seam located near the end of the raw bar. During the forging process the orientation of this discontinuity was changed transversely.

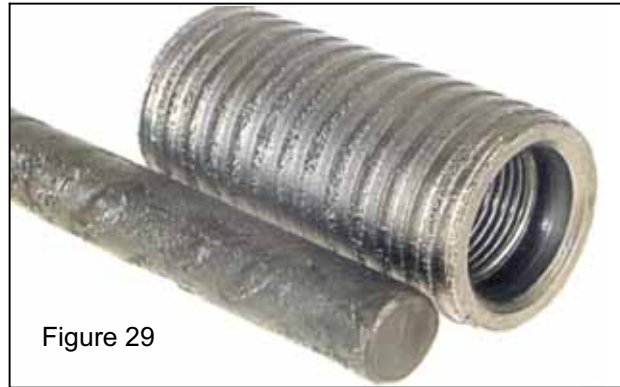
Figure 29 is an example of processing defects. The lower example is a casehardened sucker rod and the upper example is a coupling that has been processed through a grinding operation to reduce the diameter. In both examples, a difference in the material hardness has resulted in preferential corrosion attack.

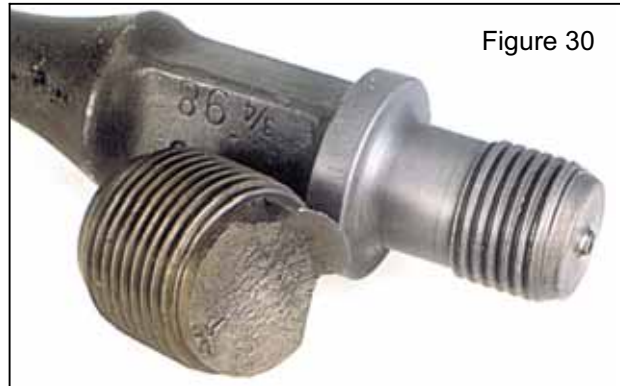
Figure 30 is an example of a mill defect and a machining defect. The lower example is a failure due to a large, internal, nonmetallic inclusion in the pin. The fracture began internally and is brittle or granular in appearance. A crack initiation site may or may not be visible and a fatigue portion may not be present on the fatigue fracture surface. The upper example is from rolling the pin threads twice. Rolling twice has flattened the pin thread crest and will not be capable of achieving the correct friction load required for makeup.
